Beechcraft

# Multi-Engine Turboprop Communiqué

Communiqué ME-TP-0016 Rev 2  
Original Issued September 2019  
Revision Issued July 2020

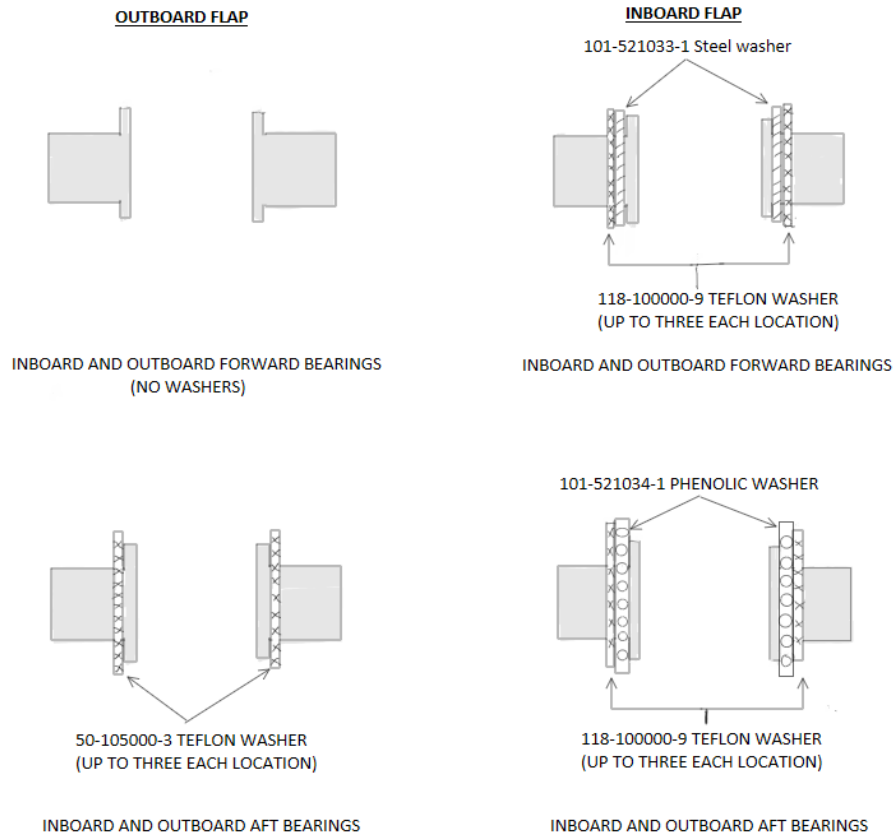
## **Chapter 27 - Flap Roller/Washer Installation** **200/300 Series**

King Air Communiqué 2000-04 illustrated the inboard and outboard flap bearing and washer orientations, however, engineering has changed slightly since that article was written; The 118-100000-9 Teflon washers are now added to both the forward and aft positions for the inboard flap and up to 3 ea. Teflon washers can be installed to prevent interference in each location.

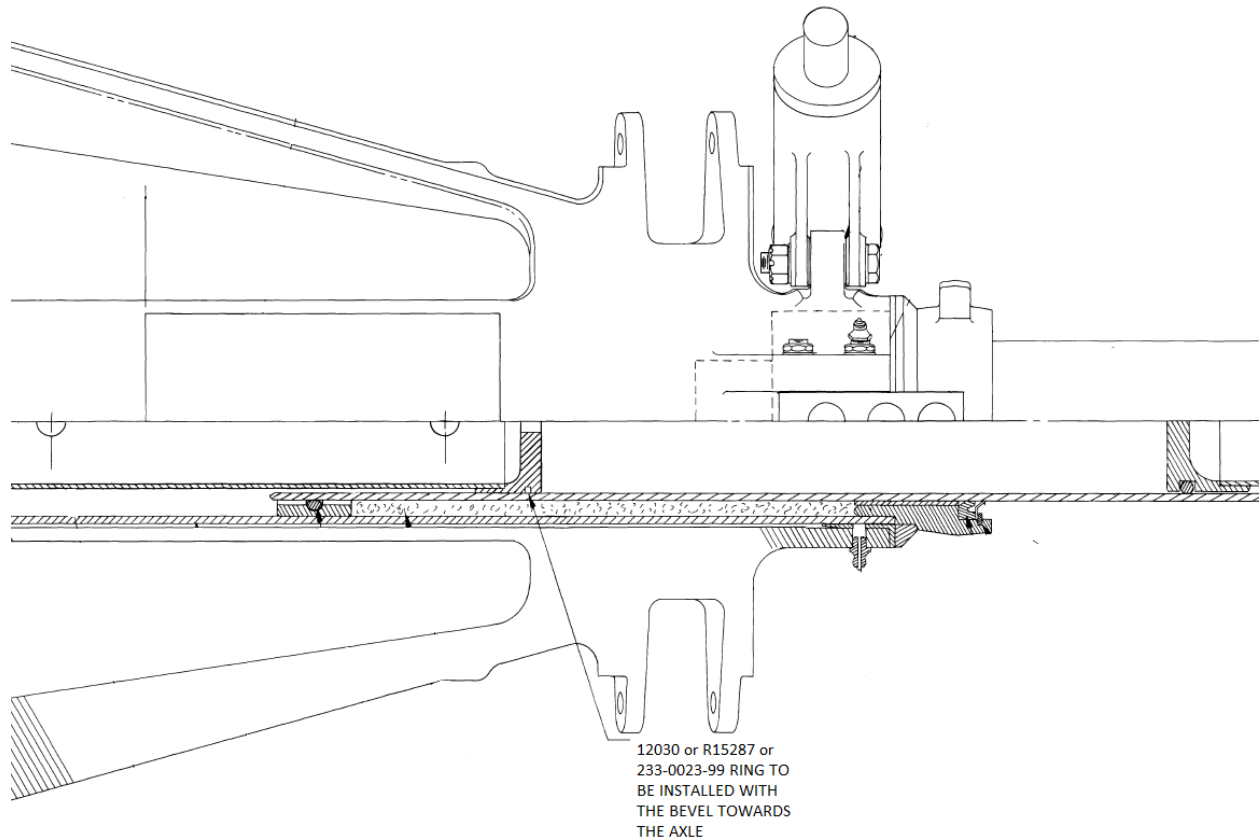
## **ATA 32 – Nose Landing Gear Installation 233-0023-99 or 12030 or R15287 Ring** **All**

The nose landing gear requires the installation of P/N 233-0023-99 or 12030 or R15287 ring. This ring has a bevel cut on it. We continue to receive questions related to the orientation of the ring. This ring should be installed with this bevel facing towards the axle.

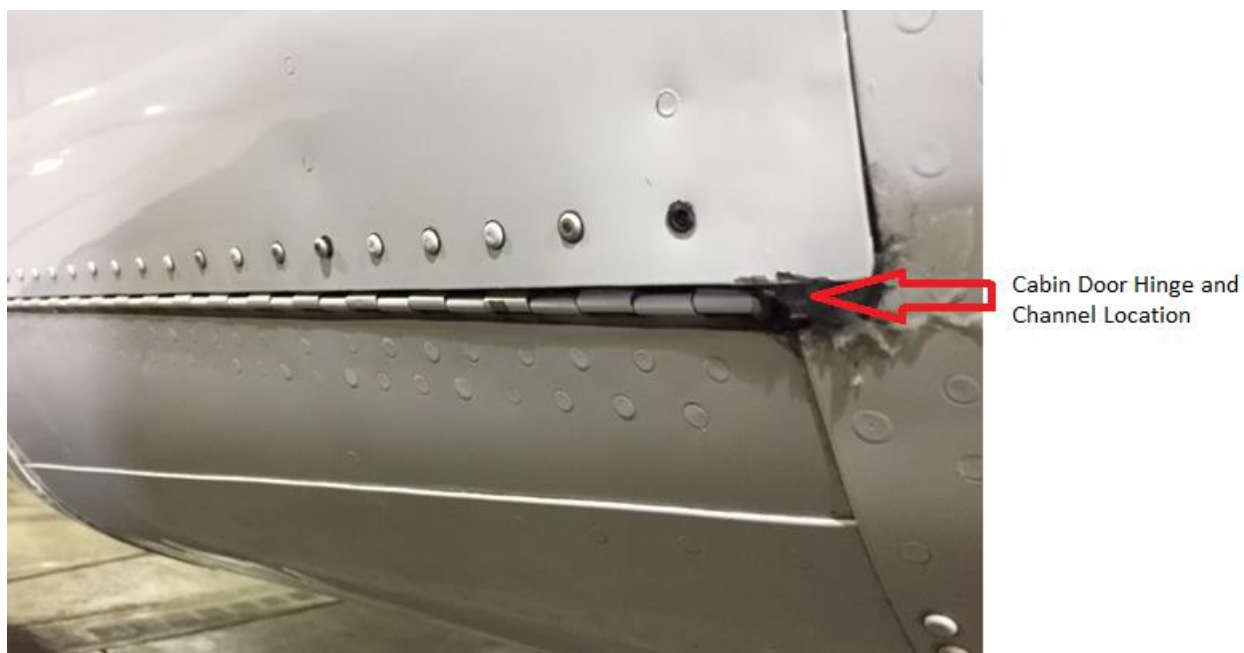
## **ATA 52 – Cabin Door Channel Part Number 50-430043-1329 Cracking** **All**

We continue to receive reports that channel part number 50-430043-1329 is cracking. This channel is located at the cabin door hinge as shown in the picture below. When this channel cracks it causes damage to the hinge. This condition is more prominent on airplanes equipped with only one handrail cable although it can also occur on airplanes with the dual cabin door handrail if the cables are not rigged so that both cables can share the load of passengers using the door.

Textron Aviation has developed a channel made from heavier material that can be used to replace the current channel. The procedure and part number of the new channel can be found in the King Air Structural Inspection and Repair Manual Chapter 52-00-01.
