Multi-Engine Turboprop Communiqué

Communiqué ME-TP-0021
July 2020

ATA 34 King Air Weather Radar

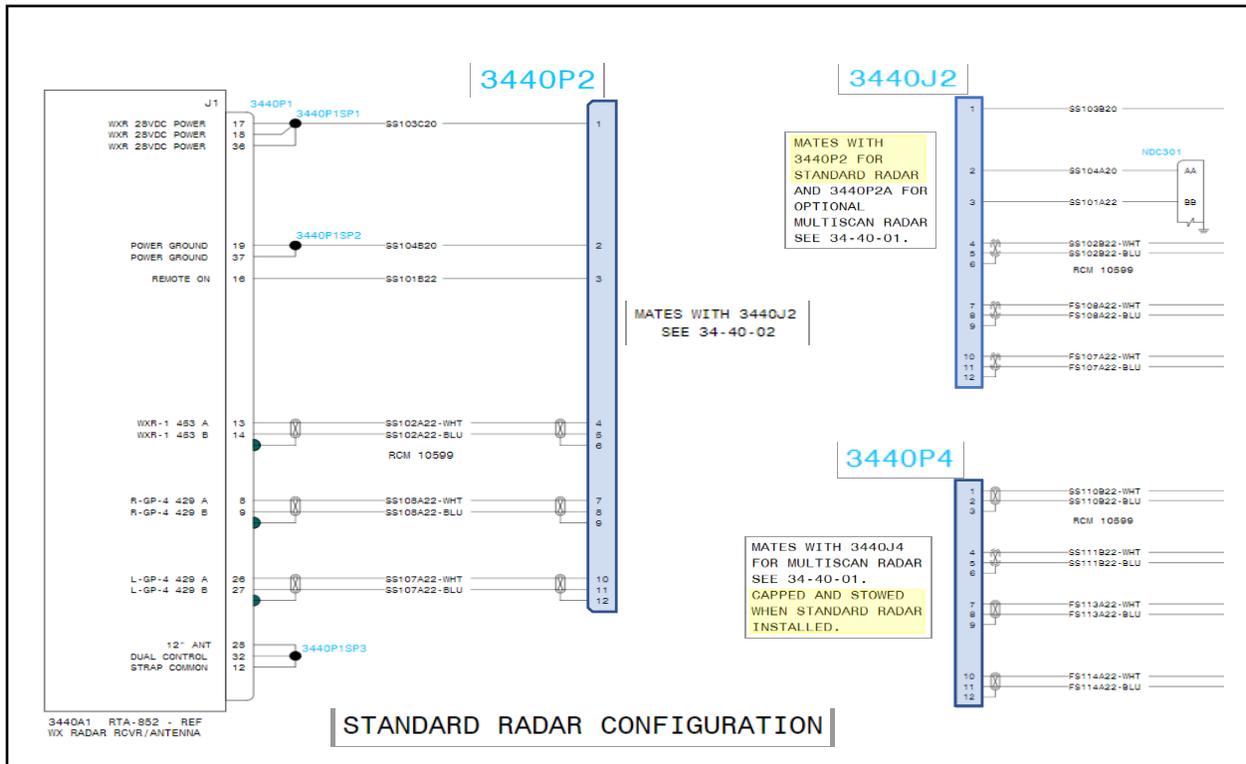
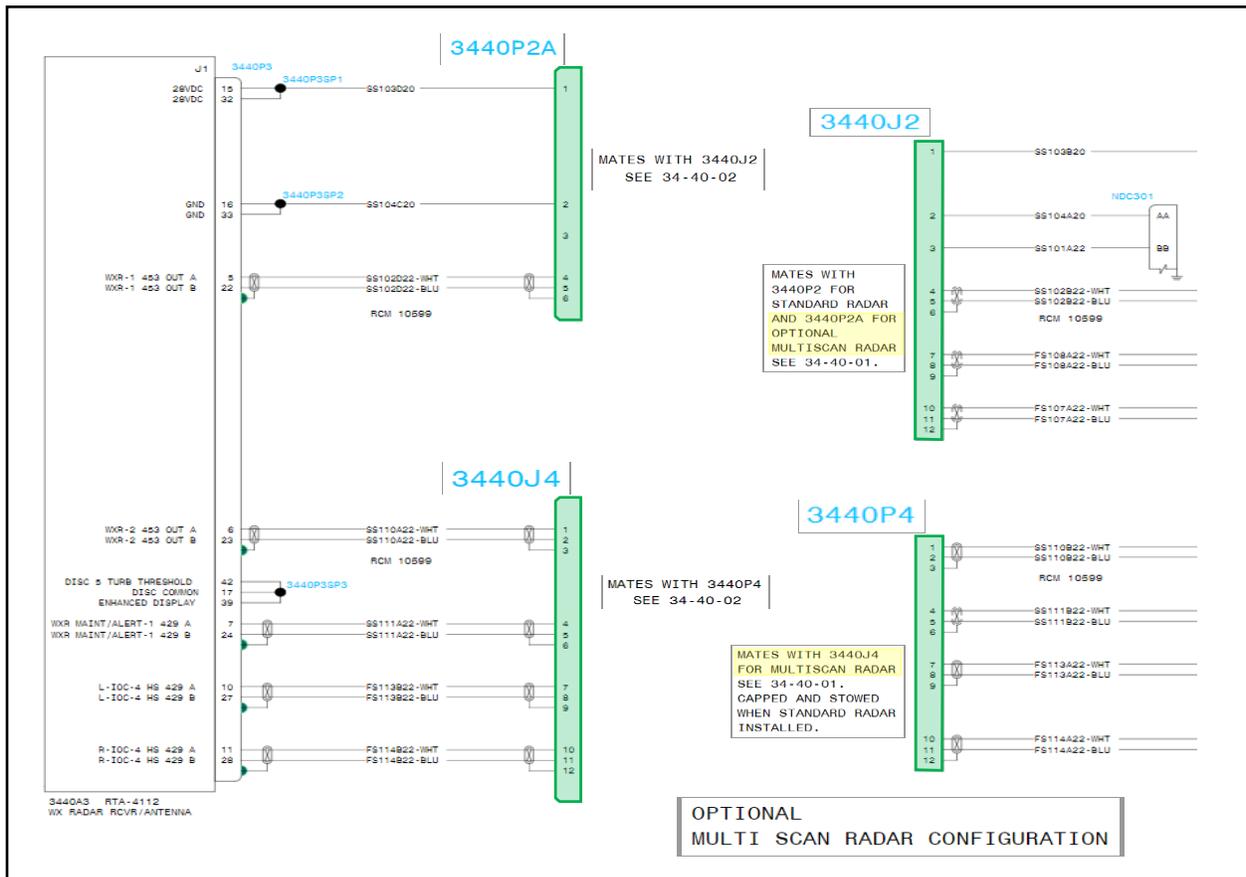
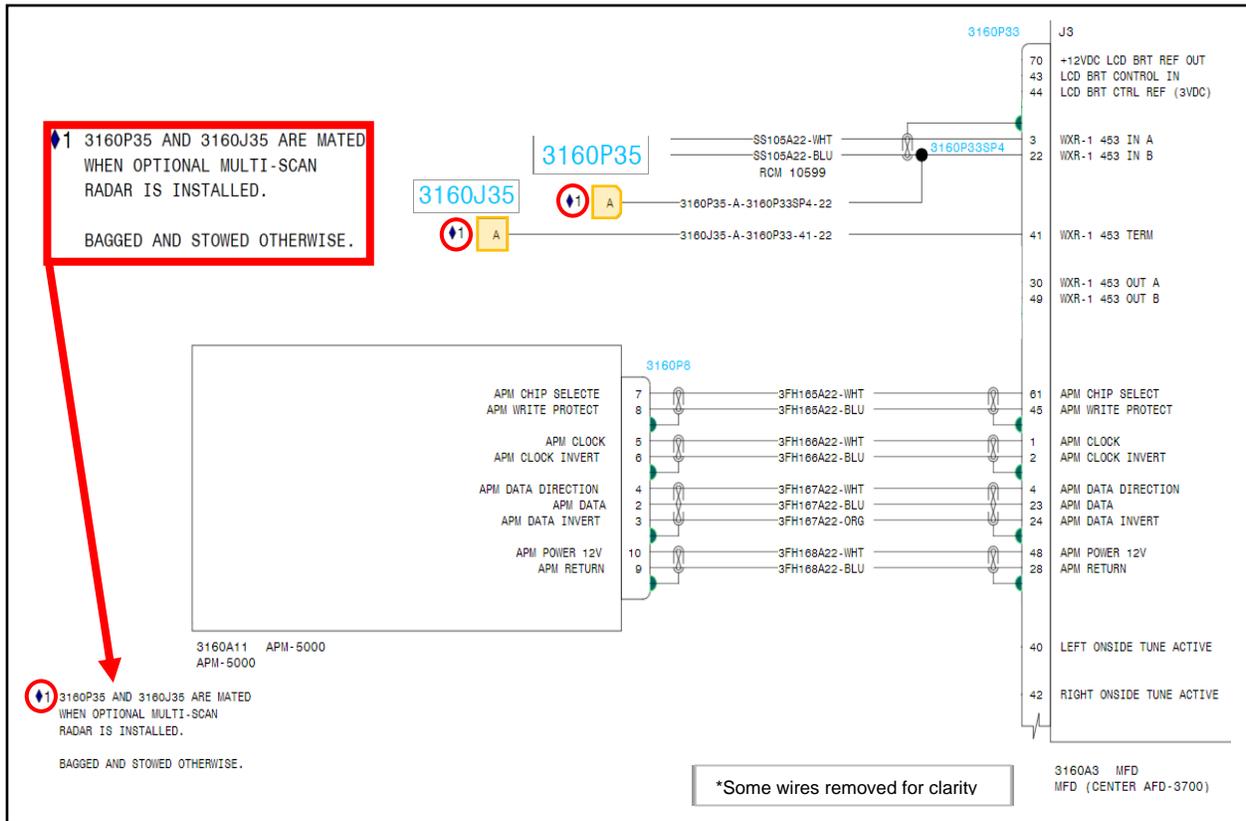
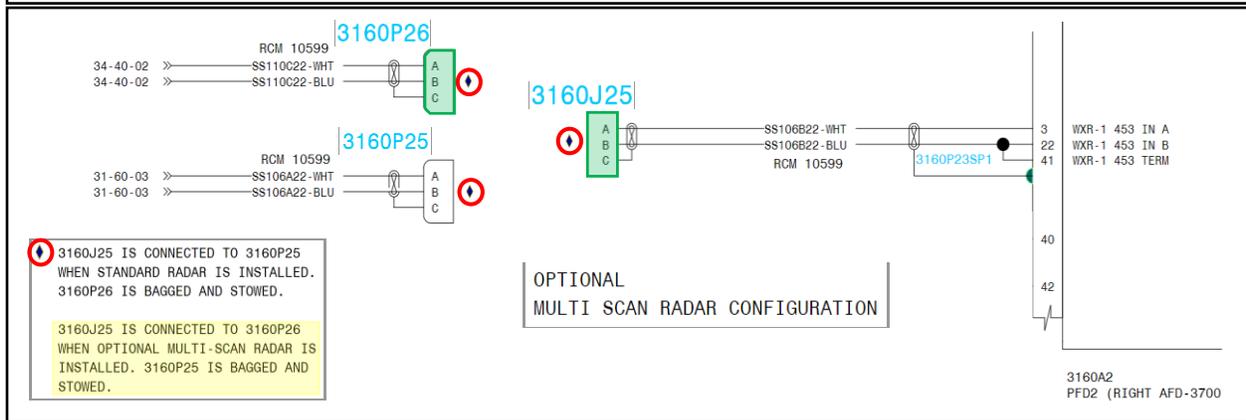
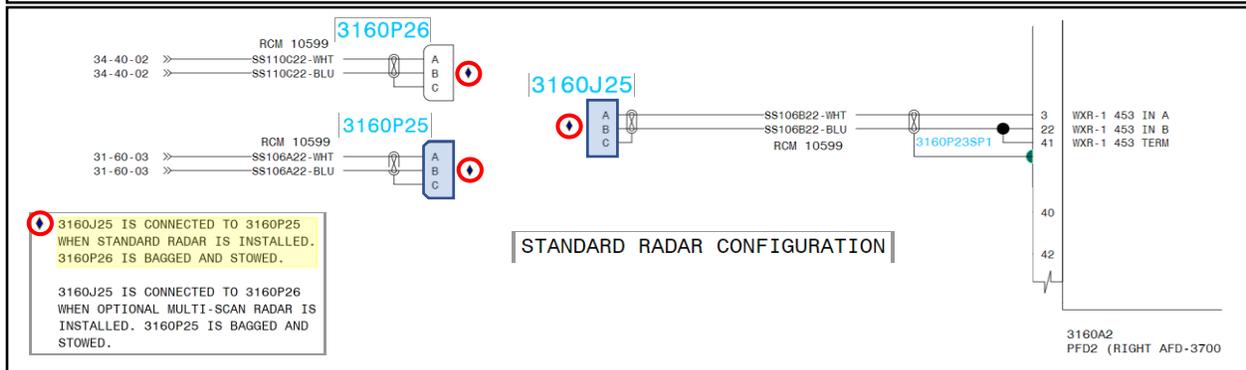
The RTA-582 WXR provides a single output that is daisy-chained to all AFD's. The MultiScan RTA-4112 WXR provides data to each side of the flight deck display system. If the connectors or the wiring for these systems become switched, the system will not function properly. Many of the same receptacles are used throughout the wiring harnesses for both systems. Utilize the notes on the wiring diagrams to verify that the correct connectors are paired. When identifying the connectors and wiring of the system for the weather radar receiver, use 34-40-01 Figure 2 and 34-40-02 Figure 1 of the Wiring Diagram Manual for reference. When identifying the connectors and wiring of the system for the AFD's, use 31-60-02 Figure 5 and 31-60-03 Figure 3 of the Wiring Diagram Manual for reference.

Standard WXR	
<i>Receiver</i>	
3440P2	→ 3440J2
3440P4	→ (CAPPED)
<i>Center AFD</i>	
3160P35	→ (CAPPED)
3160J35	→ (CAPPED)
<i>Right AFD</i>	
3160P26	→ (CAPPED)
3160P25	→ 3160J25

MultiScan WXR		
<i>Receiver</i>		
3440P2A	→	3440J2
3440P4	→	3440J4
<i>Center AFD</i>		
3160P35	→	3160J35
<i>Right AFD</i>		
3160P26	→	3160J25
3160P25	→	(CAPPED)
